**Lummi Nation Wetland and Habitat Mitigation Bank**  
**2012 (Year 1) Monitoring Report for 2011 Enhancement Areas**  
**Phase 1A Nooksack Delta Site**

**July 2013**

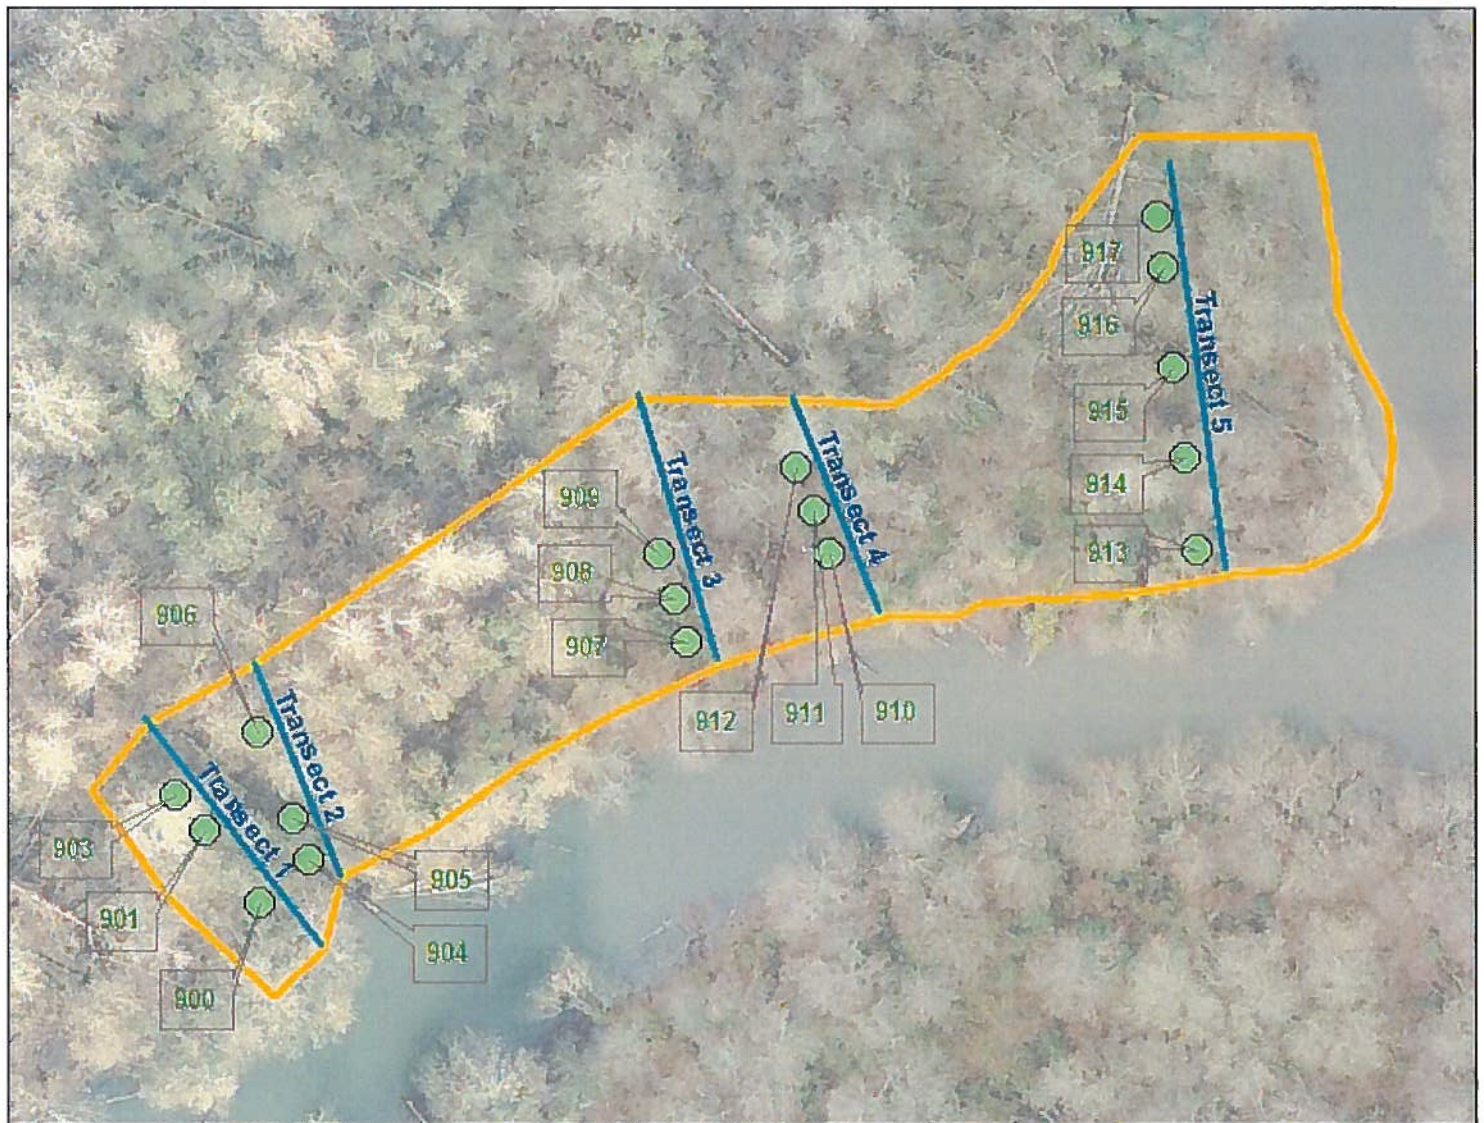
Figure 3. English Ivy Removal Area 2011 (Phase 1A)

The perimeter of the English ivy infestation area was surveyed with a GPS unit during 2011 to aid with maintenance and monitoring. Randomly placed transects were set up and monitored in 2011 within the ivy infestation area to measure the baseline condition before treatment (Figure 3). Line intercept sampling was conducted along the transects and visual estimates of ivy cover were made within 10-foot diameter plots adjacent to the transects. Pre-treatment monitoring showed that average ivy cover was 30.4% (SE 8.9) in the sample plots and 42.7% (SE 28.7) along line intercept transects.

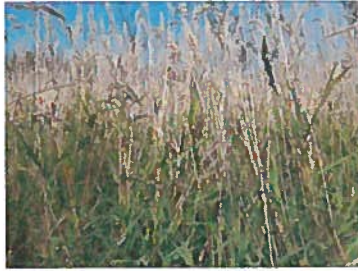
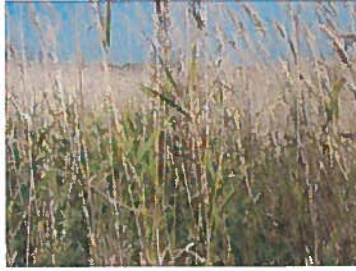
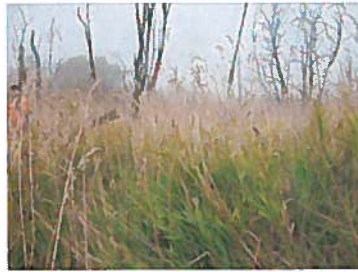
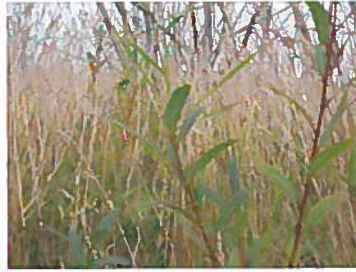
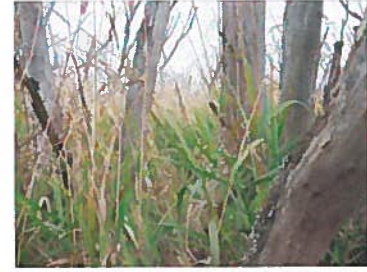
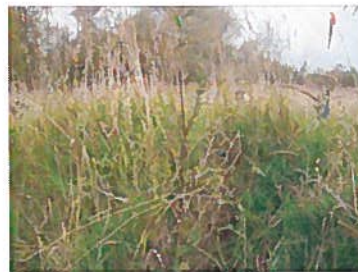
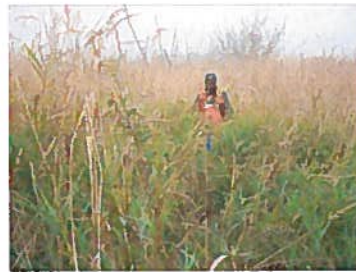
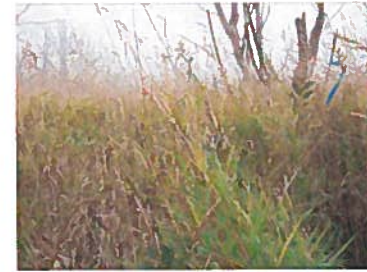
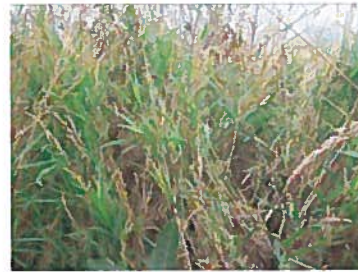
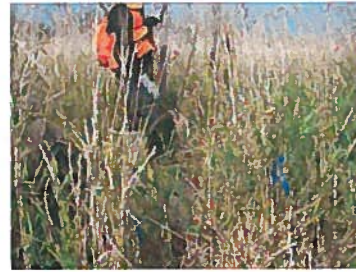
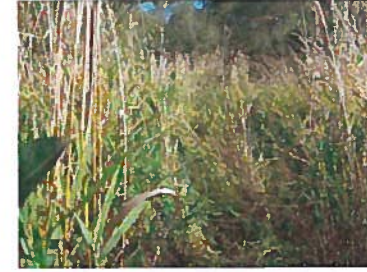
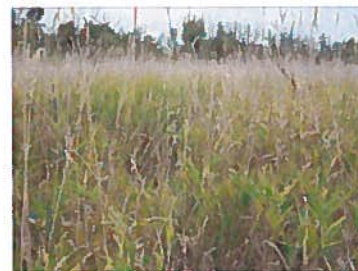
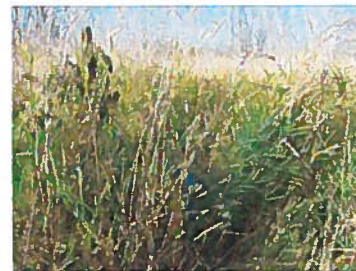
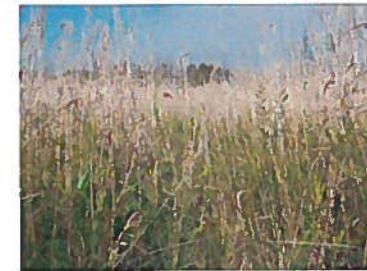
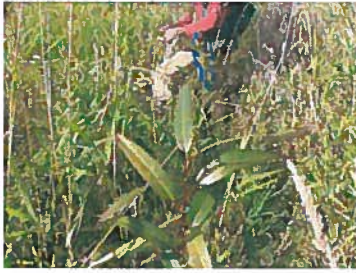
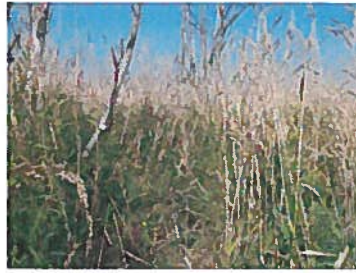
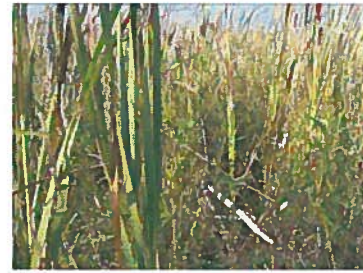
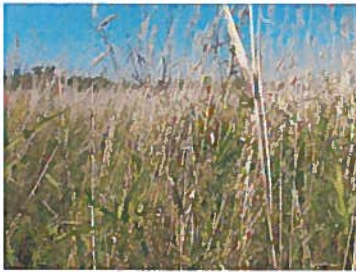
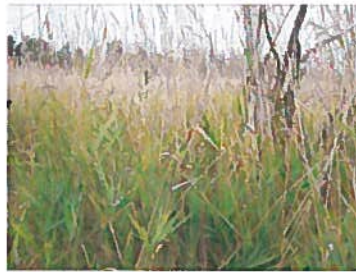
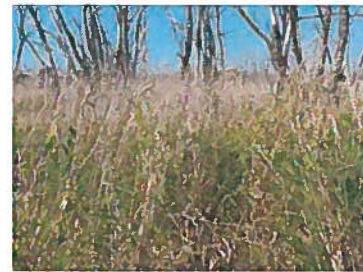
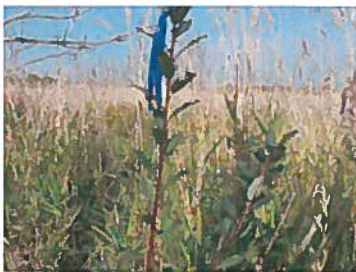
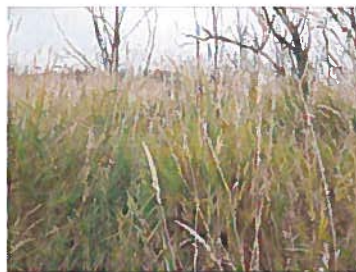
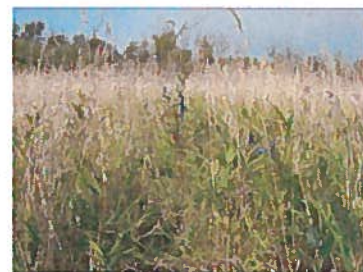
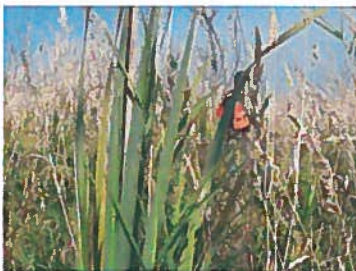
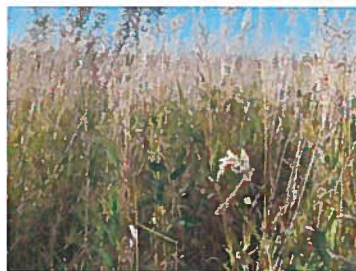
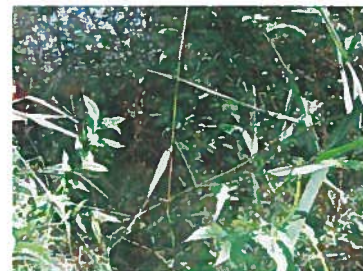
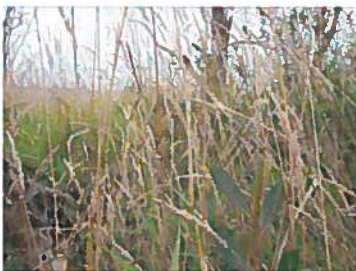
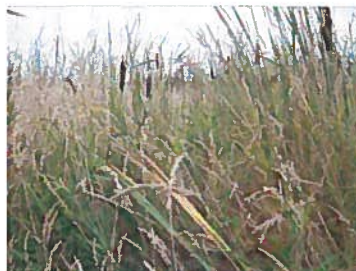
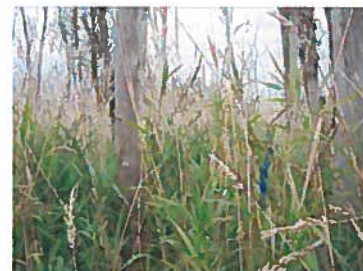
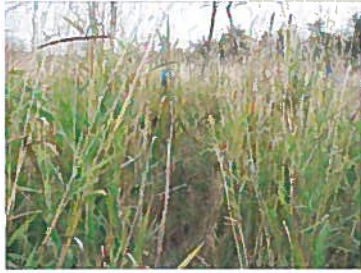
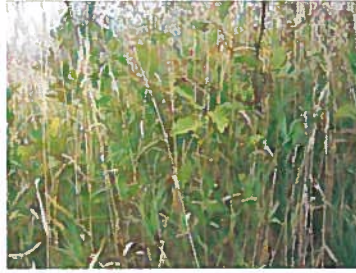
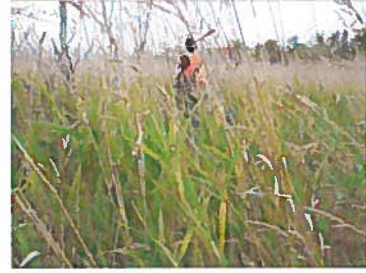
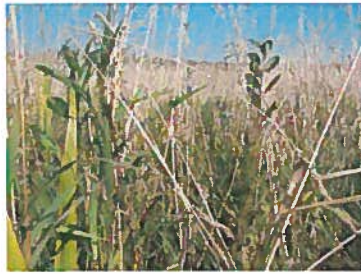
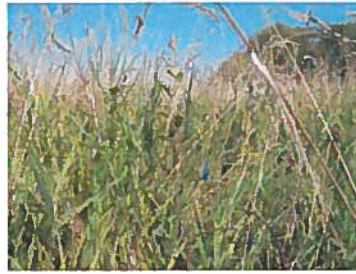
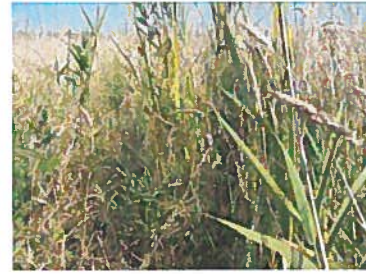
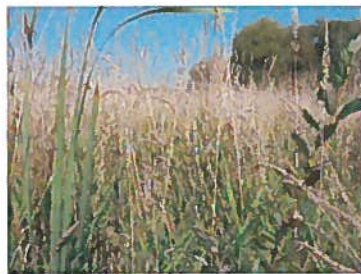
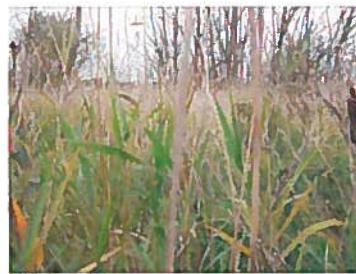
Results of the aerial coverage estimates are shown in Table 3. Only three of the plots were estimated to have 10% or greater shrub cover. The average coverage provided by native shrubs over all 38 sample plots decreased from 13.7% (SE 1.17) in Year 0 to 4.5% (SE 0.67) in Year 1. The decrease in cover is the result of some willow stakes dying between years. The 4.5% cover estimate does not meet the performance standard of 10% by Year 1 as described in the MBI.

Although growth was vigorous on many of the live willow stems, growth was also vigorous for the reed canary grass and many dead willow stems were observed within the sampled plots. Evidence of bark browsing (probably due to voles) was observed on many of the dead stems. Stems drying prior to planting or dry conditions during the summer establishment period may also have contributed to stem death, which resulted in a decrease in shrub cover. Replanting of some willow plots may be necessary in order to meet Year 3 performance standards of 20% shrub cover.

(Photographs taken in September 2012 from south end of sample plots facing north.)

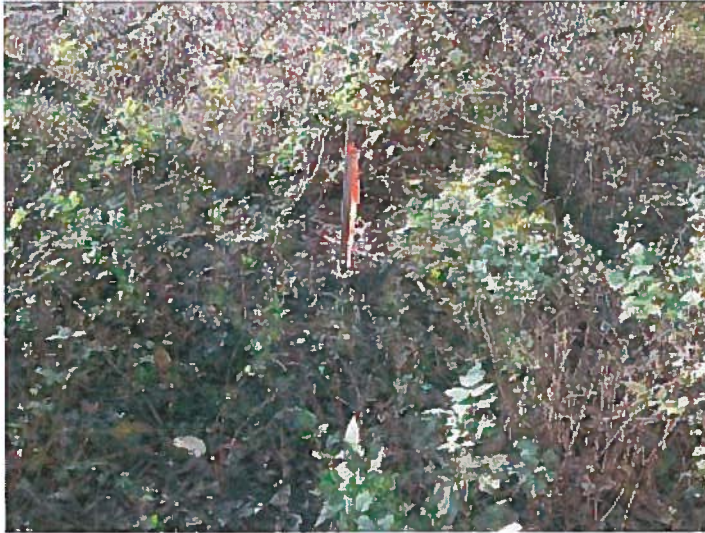
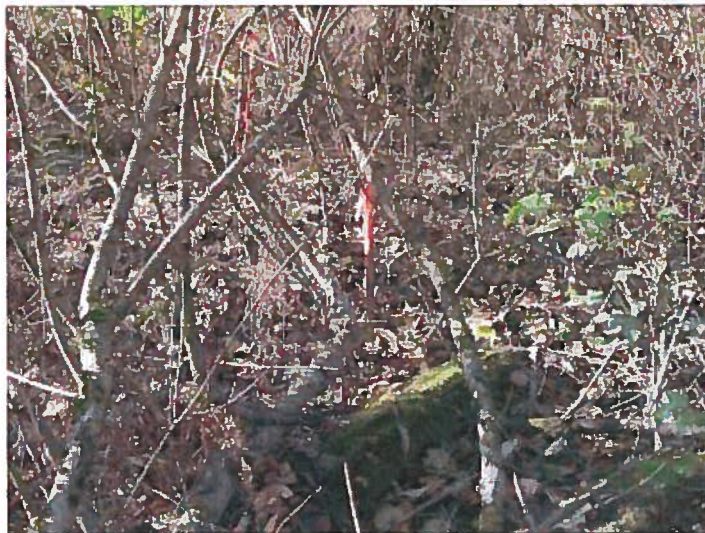
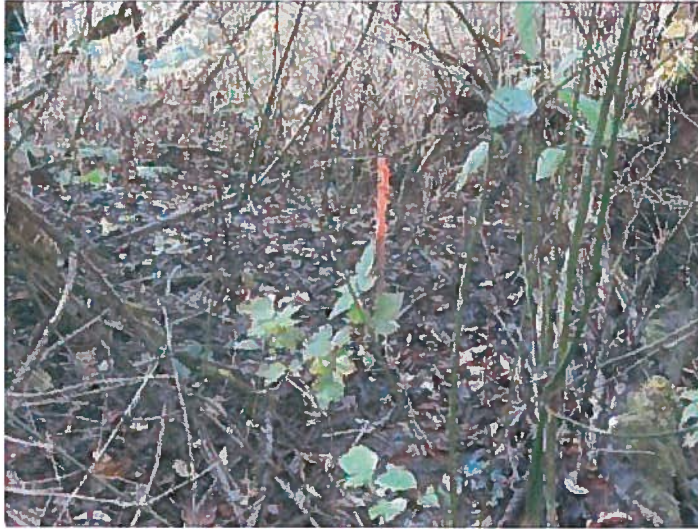
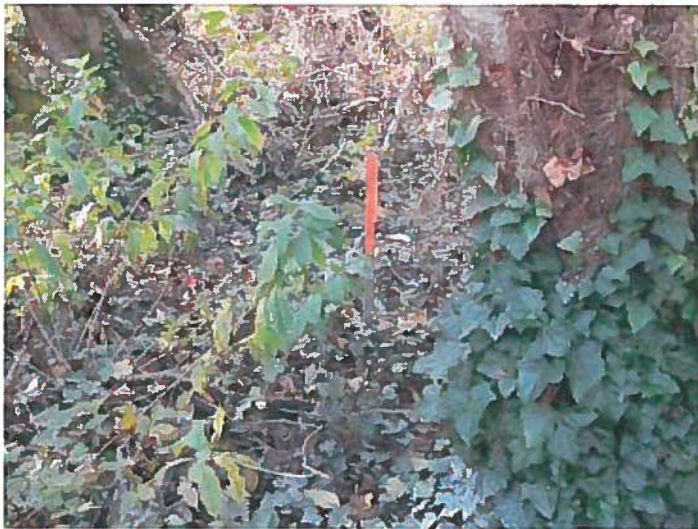
Photographs showing the conditions along ivy removal transects in November 2012 are provided in Appendix B. In 2012, the average ivy cover was 10.8% (SE 5.5) in the sample plots and 35.6% (SE 31.7) along line intercept transects. Beginning in summer 2013, work on this site will involve spot spraying with herbicide of new English ivy sprouts. With continued treatment of the remaining ivy, the site should be on track to meeting performance standards in Year 3 (2014).

Photographs taken in fall of 2012. Ivy control efforts were conducted during fall of 2011.
